ENGINEERING REPORT

CULLOWHEE DAM EVALUATION
WESTERN CAROLINA UNIVERSITY
TUCKASEIGEE WATER & SEWER AUTHORITY

JACKSON COUNTY, NORTH CAROLINA

July 2017

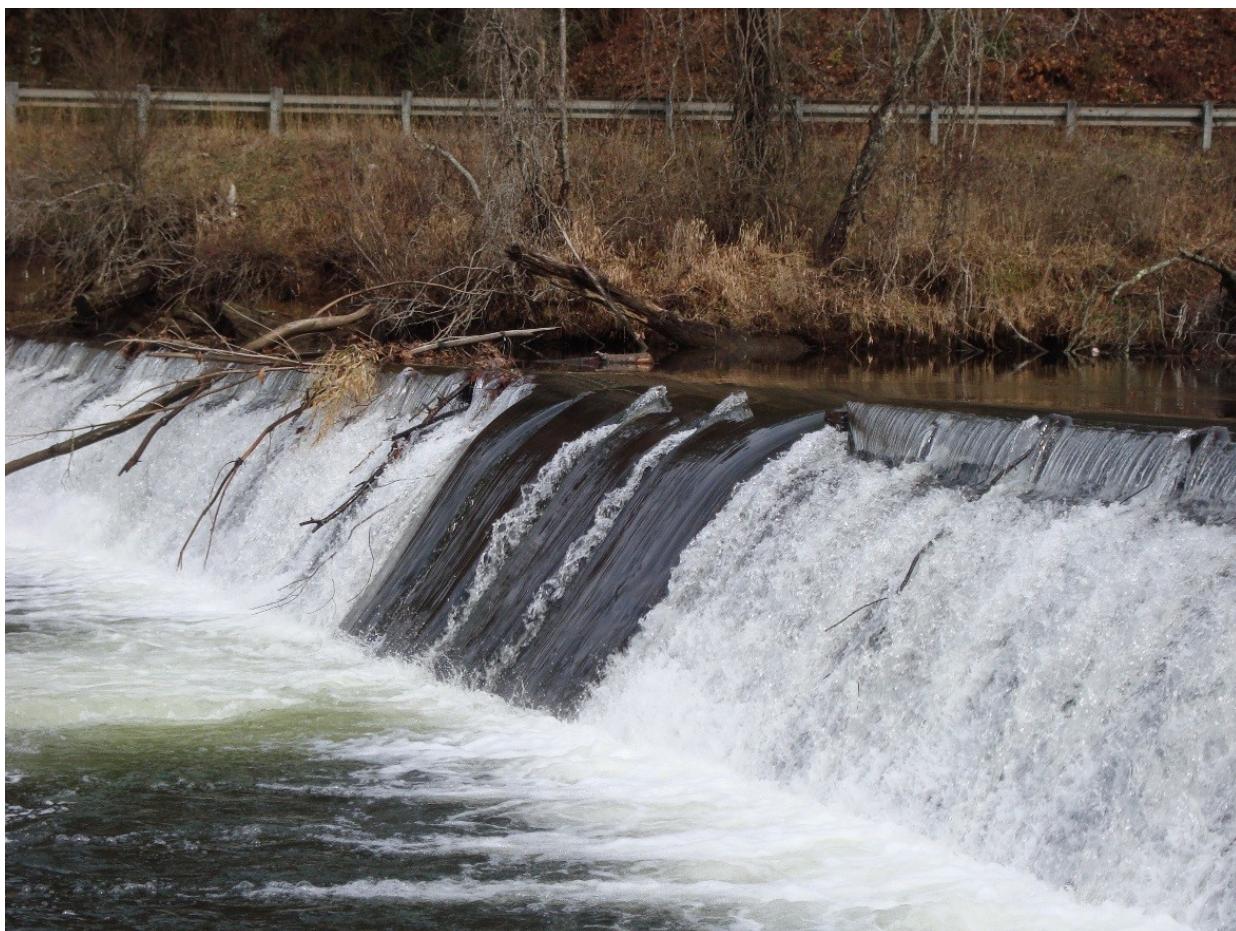
Figure 4. Flashboards Removed from Mid-Section (4 Bays) of Cullowhee Dam

Our field inspection on January 2, 2017, required the removal of flashboards from four of the 32 bays (shown on Figure 4), which was performed by In-Water Services of Greensboro under contract to WCU. These flashboards had been originally furnished and installed by In-Water Services in April 2016 near the middle of the overflow section (between stations 0+80 and 1+00, as shown on Figure 1), and consisted of three timber planks each 12 inches wide, 3 inches thick, and 10 feet, 4 inches long. The planks were bolted to existing pipe supports to span the four 5-foot openings on the dam crest, replacing older flashboards damaged or destroyed by previous floods. The total 20-foot wide opening was expected to pass between 70 and 80 cubic feet per second (cfs) below the top of the remaining flashboards; however, the river flow during the inspection exceeded this capacity, resulting in overtopping of the flashboards by about one inch across the remaining 140-foot length, for an estimated additional 15 to 20 cfs. Duke Energy had agreed in advance to suspend their normal daily upstream releases for peaking power, so that only base flow was passed through the dam-site during our inspection, which occurred between 10 am and 3 pm. The nearest (upstream) river gage (USGS 03508050) represented only 147 mi² of the estimated 207 mi² total drainage area at the dam site (see Figure 21), and did not include flows from Wayehutta and Caney Fork Creeks, which are unengaged.

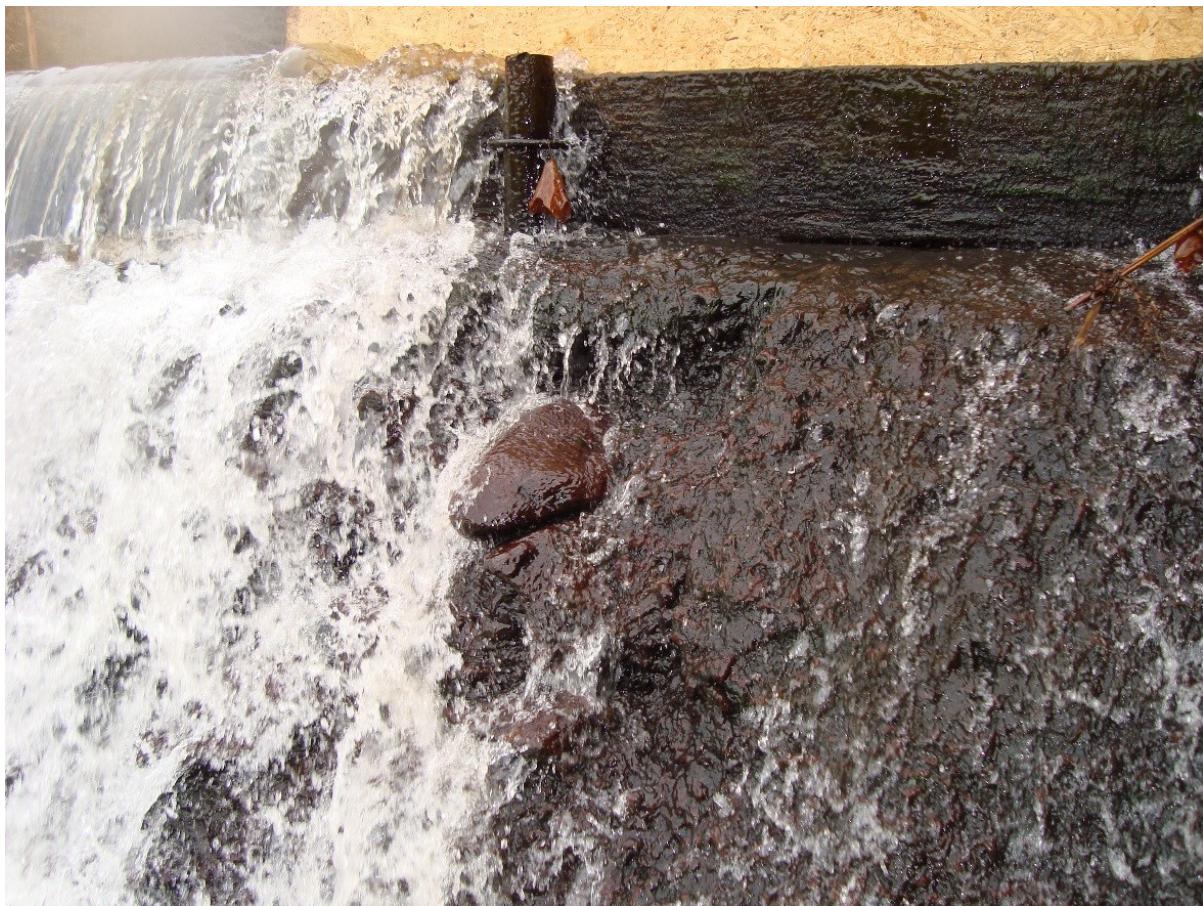
Figure 5. Close-up View of Unwatered Downstream Face of Dam

The field inspection of the concrete overflow section included visual examinations to the extent possible at selected areas of the downstream face, wading along the downstream toe to identify undercut areas, manual probing of undercut areas with a 4-foot long rod, and wading along the upstream face to determine sediment depths. A plywood sheet was used by In-Water Services at the upstream face to divert overtopping flow away from selected areas to permit observation of the concrete surface, which was found to be in generally satisfactory condition, but with isolated pockets of abrasion damage exposing larger cobbles used in the concrete (as shown on Figure 5). One or two irregular lift lines appeared to be present through the overtopping flow, but no evidence of disbonded or open joints were observed at the selected areas. Although a 160-foot-long concrete structure would be expected to require vertical joints or display vertical cracks (at least at the quarter-points), none were observed. Independent structural measurements and concrete strength testing could not be performed as originally planned due to the overtopping flow. The raw water intake and pumping station drawings indicate the top of weir (overflow section) to be at elevation 2060.75 (NAVD88), which is believed to represent the top of the 12-inch high flashboards. Survey data collected following our field inspection indicated the top of the flashboards to be at elevation 2060.37 (or about 0.4 feet lower), which has been adopted for our project drawing (see Figure 1) and structural analyses.

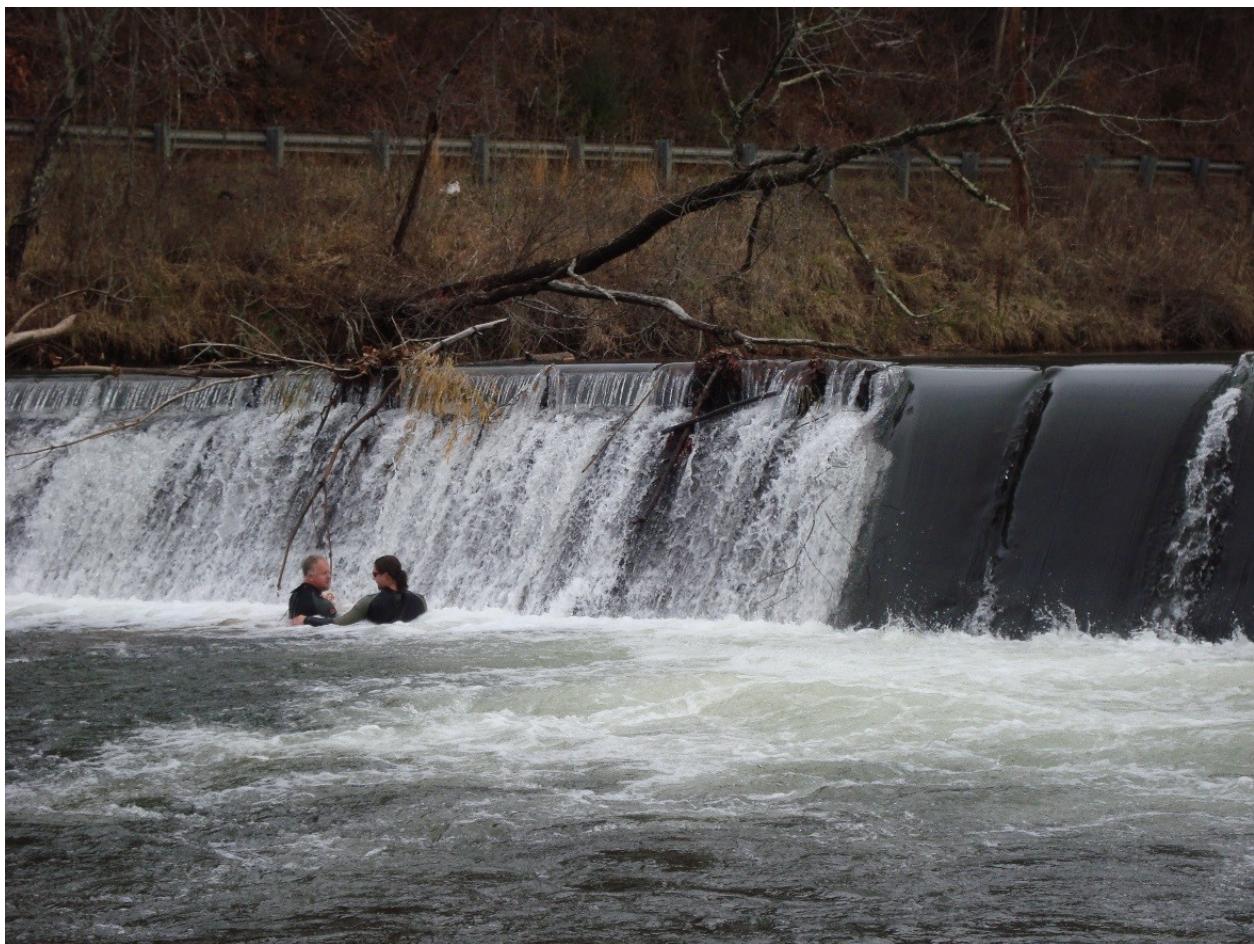
Figure 6. In-Water Services Personnel at Location of 3.5-Foot Deep Undercut Area

In-Water Services (Mike Brian) reported a large undercut area at the downstream toe of the overflow section approximately 60 feet from the right abutment (station 0+65, as shown on Figure 6), which extended at least 3.5 feet upstream beneath the downstream toe of the concrete structure. This area also generally coincided with an area of little or no sediment upstream, and may have originally represented the thalweg (line of lowest elevation within a watercourse) of the river. The undercut was estimated to be approximately 3-feet wide and 1.5-feet high at the toe, and appeared to be within the structure foundation. No other evidence of structure undercutting was observed, other than a reported 3 to 4 inches near the left abutment (station 1+50), which would be considered minor. Tailwater was generally waist-deep for the majority of the overflow section, with somewhat shallower depths closer to the abutments. In-Water Services also measured the depths below the reservoir water surface to the top of the impounded sediment at 5-foot intervals along the upstream face of the overflow section, which were recorded and are shown on Figure 1. Again, shallower water depths were reported closer to the abutments. Two samples collected of the reservoir sediment were visually classified as silty fine sand near the powerhouse intake and fine to medium sand closer to the overflow section.

For the undercut section, the tailwater would extend an additional 3.5 feet upstream beneath the structure, and the foundation contact area for sliding would be reduced by about 43 percent (from 8.2 feet to 4.7 feet). To represent the reduced sliding resistance, a surface friction angle (ϕ) of 30 degrees was used for a reduced tangent ϕ factor of 0.577, instead of a tangent ϕ factor of 1.0 for a surface friction angle of 45 degrees. Assuming no upstream sediment at this location (based on field observations), the undercut section is unstable for a net head of 7 feet (with a sliding factor of safety of 0.91) and would slide downstream (or overturn) if not for the three-dimensional effects of the adjoining sections. With a slight increase in net head, this section could lose contact with the reduced foundation surface and develop full uplift beneath the structure. This could

produce a large hydraulic gradient (or large head over a short distance) and a potential to move sediment downstream at the foundation surface, as has apparently been observed at this location.

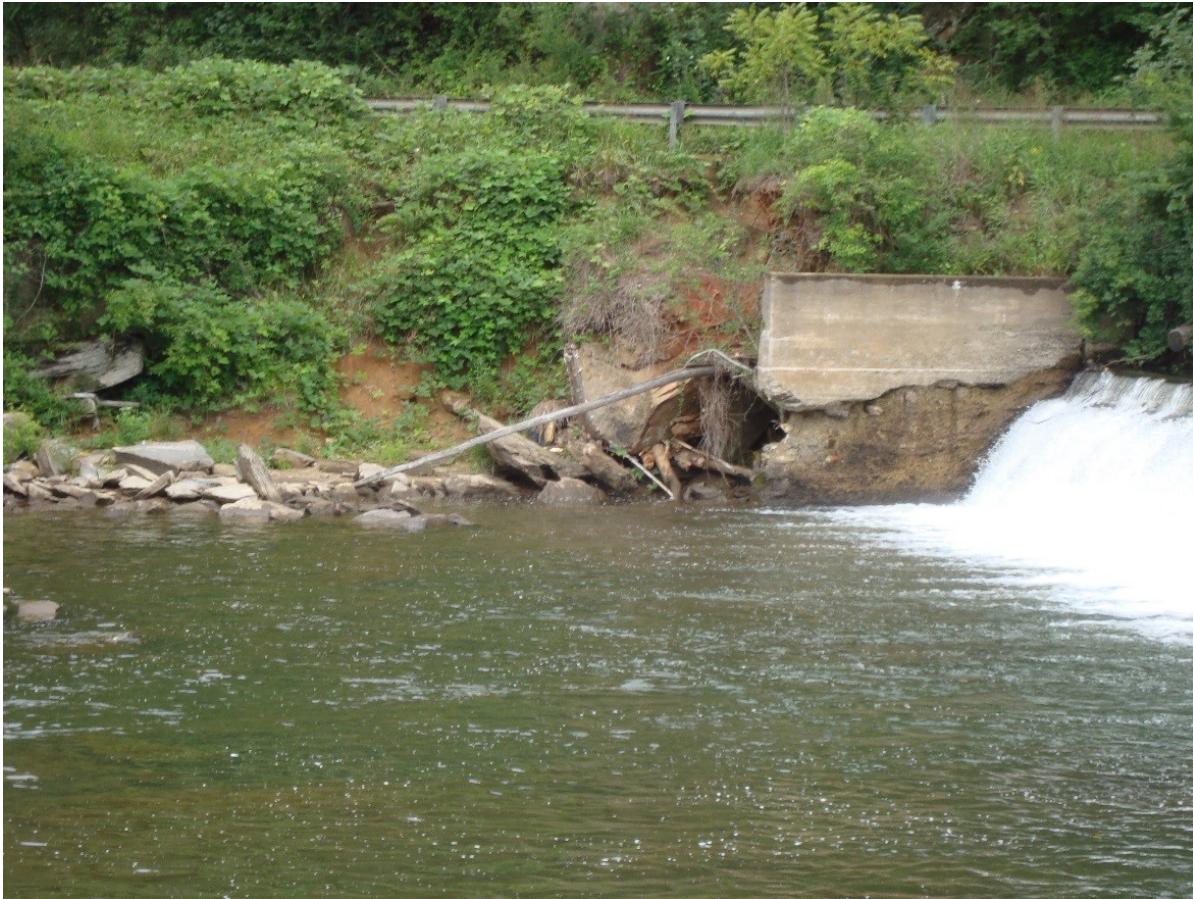
Figure 7. Concrete Sidewall and Right Abutment of Cullowhee Dam

An 18-inch thick concrete wall is located at the right end of the overflow section (as shown on Figure 7), extending approximately 2.5 feet upstream from the upstream face, and having a total length of 16 feet, 8 inches. The top of the wall is nearly 5 feet above the concrete crest, or nearly 4 feet above the top of the 12-inch high flashboards. Flows more than about one foot above the top of the flashboards, or greater than approximately 700 cfs, could produce flow behind the wall. Significant erosion has already occurred behind the wall and around a large boulder that may have slid downslope to rest against the outside face of the wall. It would appear that sustained erosion could undercut the adjoining hillslope and affect Wayehutta Road. Flow records suggest that Duke Energy could release flows exceeding 700 cfs on a daily basis at certain times of the year. The inside face and downstream end of the wall, downstream of the overflow section, was severely damaged due to abrasion and/or concrete deterioration. There was no evidence of reinforcing steel, and structural details of the wall (including the possible presence of a footing) are unknown. Thinner concrete walls were observed downstream of the right sidewall along the river bank, presumably from the foundations of structures originally located there and associated with the original timber crib dam.

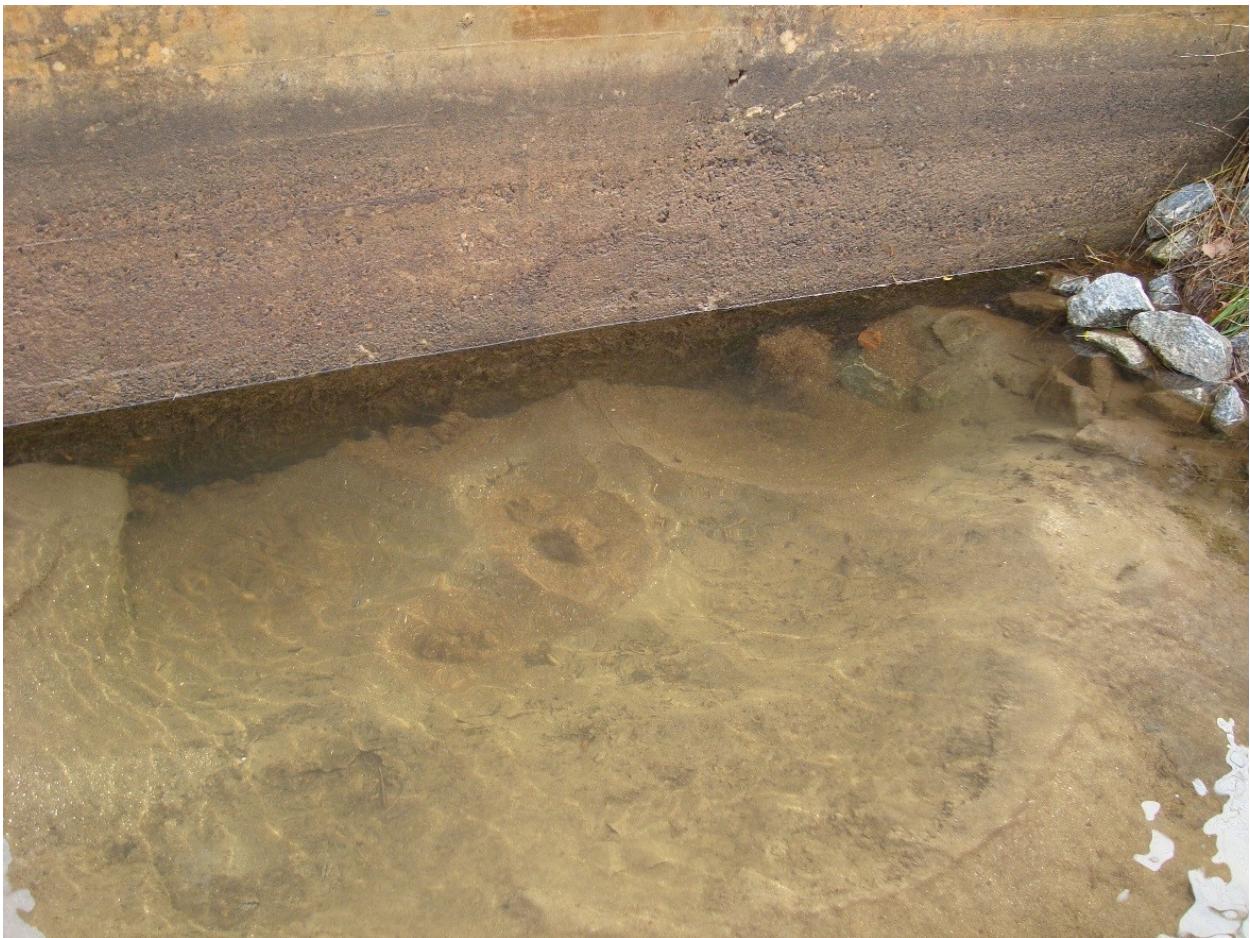
Figure 11. Sand Boils at Downstream End of Powerhouse

boils were observed at the downstream face of the powerhouse below about a foot of water depth (as shown on Figure 11), suggesting a hydraulic gradient between the inside and the outside of the structure with some interconnection. This is not of any concern, given the concrete structure is founded deep into bedrock and that some piping of sediment may be occurring from a buried structure opening under a few feet of head.

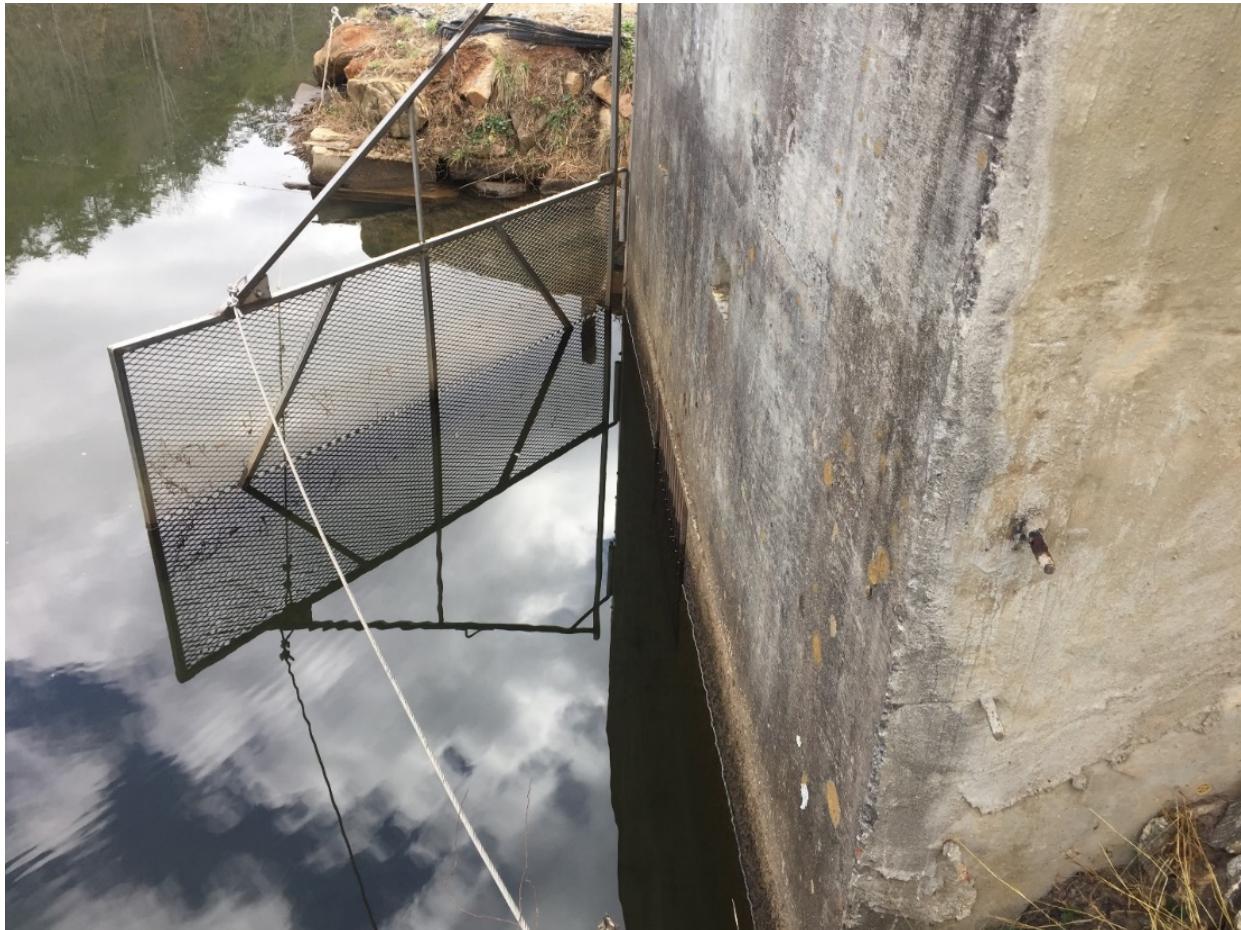
Figure 13. WCU Intake Bar Screen

Raw water enters the screening chamber through a bar screen with an invert elevation of 2058.94' and an effective width and height of 3'1". The bar screen itself consists of eleven 2" x ½" bars. The bar screen is shielded from river flows by a screen gate that is intended to protect the bar screen from floating debris as shown in Figure 13.

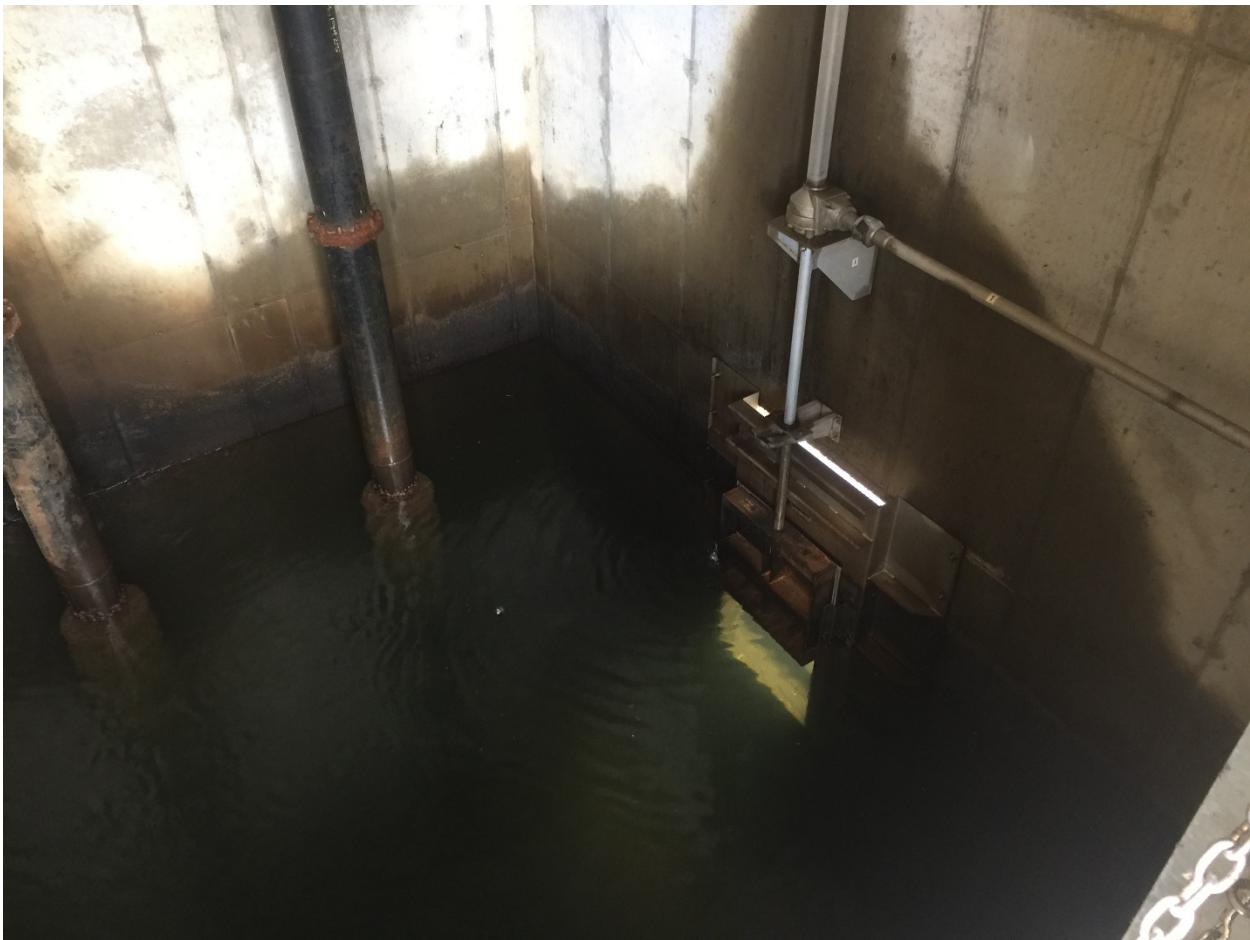
Figure 16. TWSA Intake Screen and Wet Well

Raw water flows into the wet well through a 4' wide, 5' tall aluminum mesh screen with an invert elevation of 2057.76', as shown in Figure 16. An aluminum plate can be raised or lowered behind the mesh screen to block influent flow to permit dewatering of the wet well for maintenance. The wet well invert is 3' below the screen invert at 2054.76'.
