Quantitative Evaluation of Coastal Geomorphological Changes in South Carolina After Hurricane Hugo

E. Robert Thieler and Robert S. Young

THIELER, E.R., and YOUNG, R.S., 1991. Quantitative Evaluation of Coastal Geomorphological Changes in South Carolina After Hurricane Hugo. *Journal of Coastal Research*, SI#8, 187-200. Fort Lauderdale (Florida). ISSN 0749-0208.

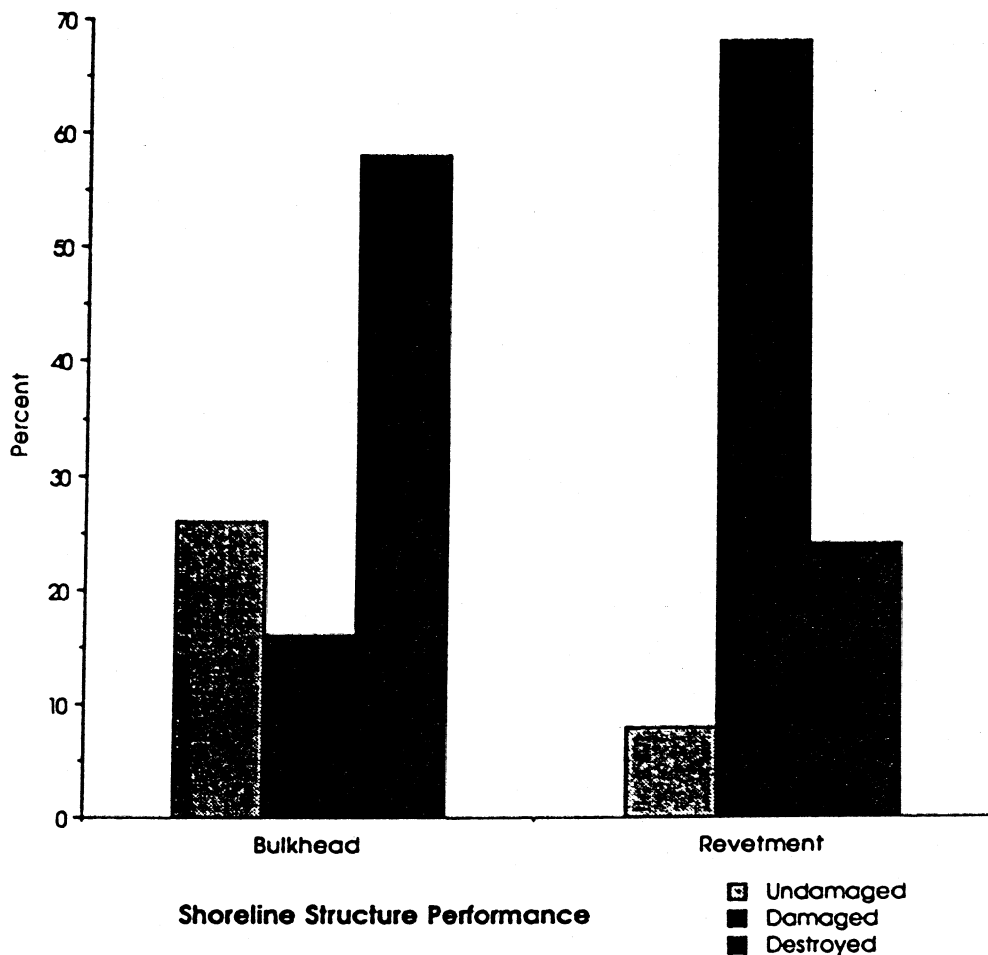
Figure 6. Column graph showing post-storm shoreline structure performance. Hard structures fronted 13.3 km of shoreline in the study area before the storm, of which 6.1 km was bulkhead, and 7.2 km revetment. See text for explanations of each category.

bulkhead and 7.2 km (14%) as revetment. Post-storm structure performance is shown in Figure 6. Fifty-eight percent of the bulkhead was destroyed, 16% damaged, and 26% undamaged. Twenty-four percent of the revetment was

destroyed, 68% damaged, and 8% undamaged. In addition, all of the bulkheads and revetments in the study area were overtopped by storm surge and waves.

The data for hard structures (see Figure 6) show clearly that bulkheads and revetments responded differently to Hurricane Hugo. Because of the nature of the structure, a bulkhead is more likely to fail completely under storm-induced stress rather than sustaining limited damage; 58% of the bulkheads were destroyed. Many undamaged bulkheads survived because they were buried under a bulldozed dune prior to the storm, which provided at least partial protection during the storm.

In the case of revetments, far more were damaged than destroyed (68% and 24%, respec-

tively). This indicates that wave activity was sufficient to move the revetment material (typically quarry stone up to 1 m in diameter), but not necessarily cause the complete destruction of the structure. Only two revetments, one on Sullivans Island and the other on Folly Beach, were classified as undamaged. It is important to emphasize that we do not take into account all outside conditions in this evaluation; rather, the data are offered as an impetus for further study.
