ENGINEERING REPORT

CULLOWHEE DAM EVALUATION
WESTERN CAROLINA UNIVERSITY
TUCKASEIGEE WATER & SEWER AUTHORITY

JACKSON COUNTY, NORTH CAROLINA

July 2017

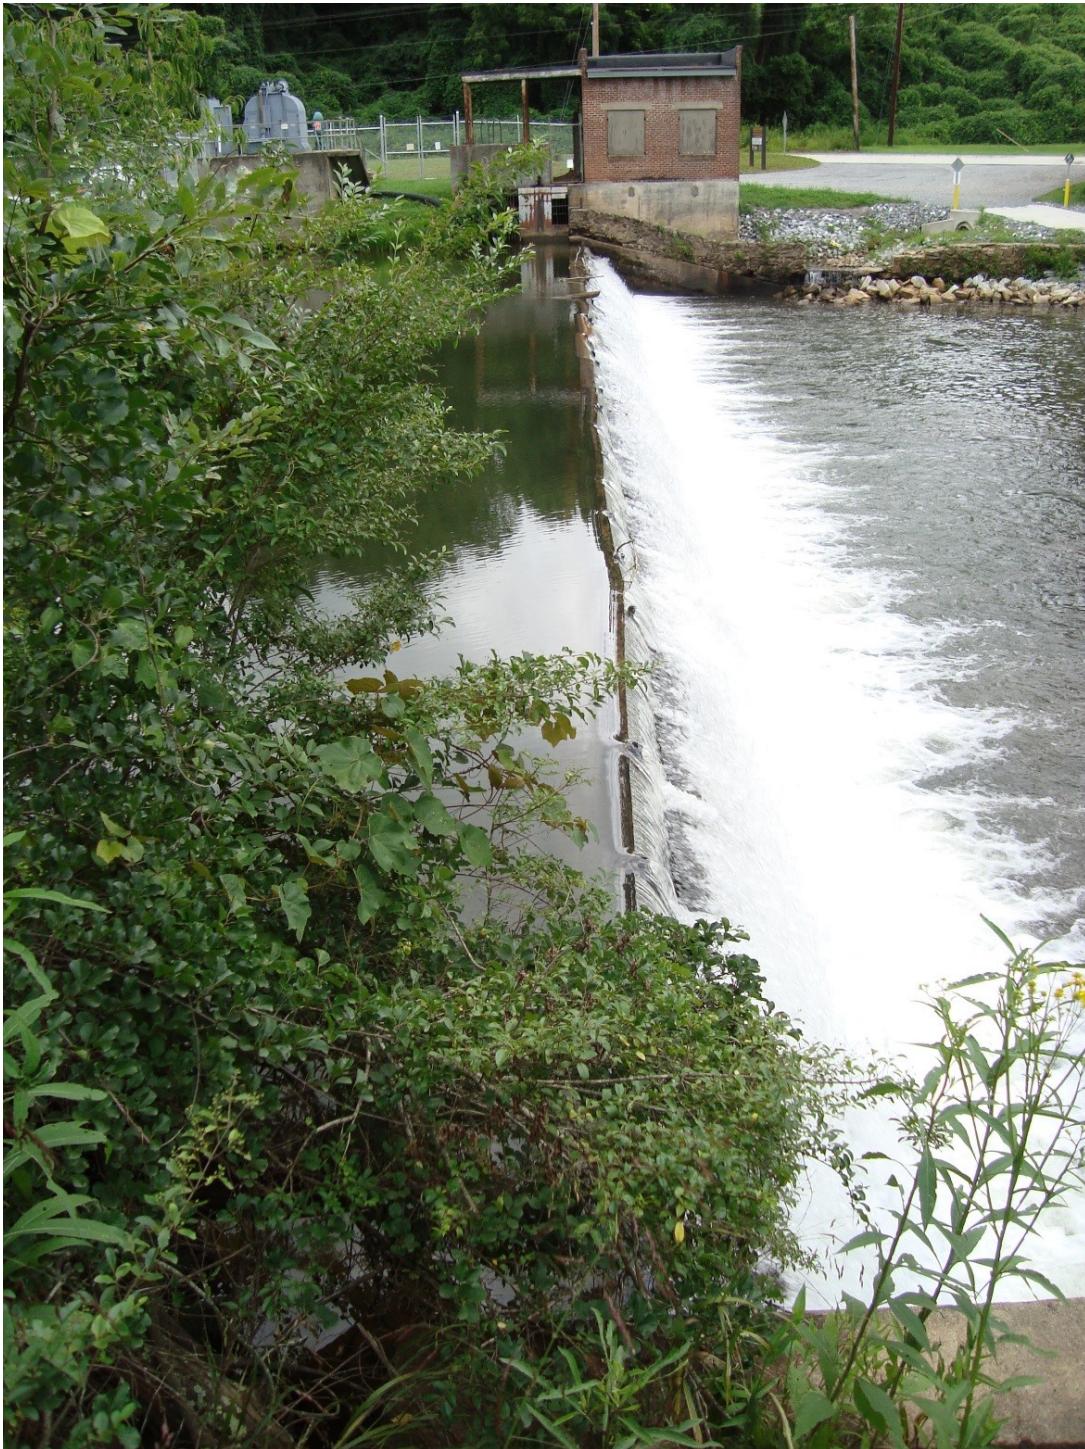
Figure 3. General Alignment of Cullowhee Dam

The concrete overflow section (shown in Figure 3) is reported to have been founded on the “solid rock of the river bed” at depths of 7 to 8 feet below the dam crest, although the south (left) abutment beyond the powerhouse consisted of soil and was breached during flood flows on August 30, 1940 and subsequently restored. The 1940 flood was reported to peak at 18 feet above the dam crest, almost completely submerging the powerhouse on the left abutment and filling the tailrace with sand (Vanderhoof, 1941). The 1941 engineering report includes a scaled cross-section of the overflow section, indicating an approximate height of 7 feet, with a vertical upstream face, a curved crest, and an estimated 0.76H:1.0V downstream slope (based on scaled measurements). The report includes a reference to 2-foot high flashboards on the dam crest both in the text and on the drawing, and includes an allowance for “flashboards and holders” in a cost estimate to extend the dam through the breach to the south. The accompanying plan view of the dam in the report scales to a length of approximately 160 feet, which is consistent with our estimate of 32 flashboard bays with a length of 5 feet each. The estimate to extend the dam “of the same shape and elevation” appears to be based on a cross-sectional area of the overflow section of about 56 ft^2 , which again is consistent with the cross-section shown on the accompanying drawing. Finally, the amount of cement in the concrete mix assumed by the 1941 report to extend the concrete dam to the south is about 590 lb/yd^3 (with correspondingly larger quantities of sand and crushed stone) which would have produced a relatively strong and durable concrete. While no information is available on the

actual concrete mix used in 1930, a design compressive strength of at least 3,000 psi is assumed based on the construction period and performance. Although the proposed concrete dam extension to the south was never constructed, the 1940 breach was repaired with earthen materials and operations were restored the following year.

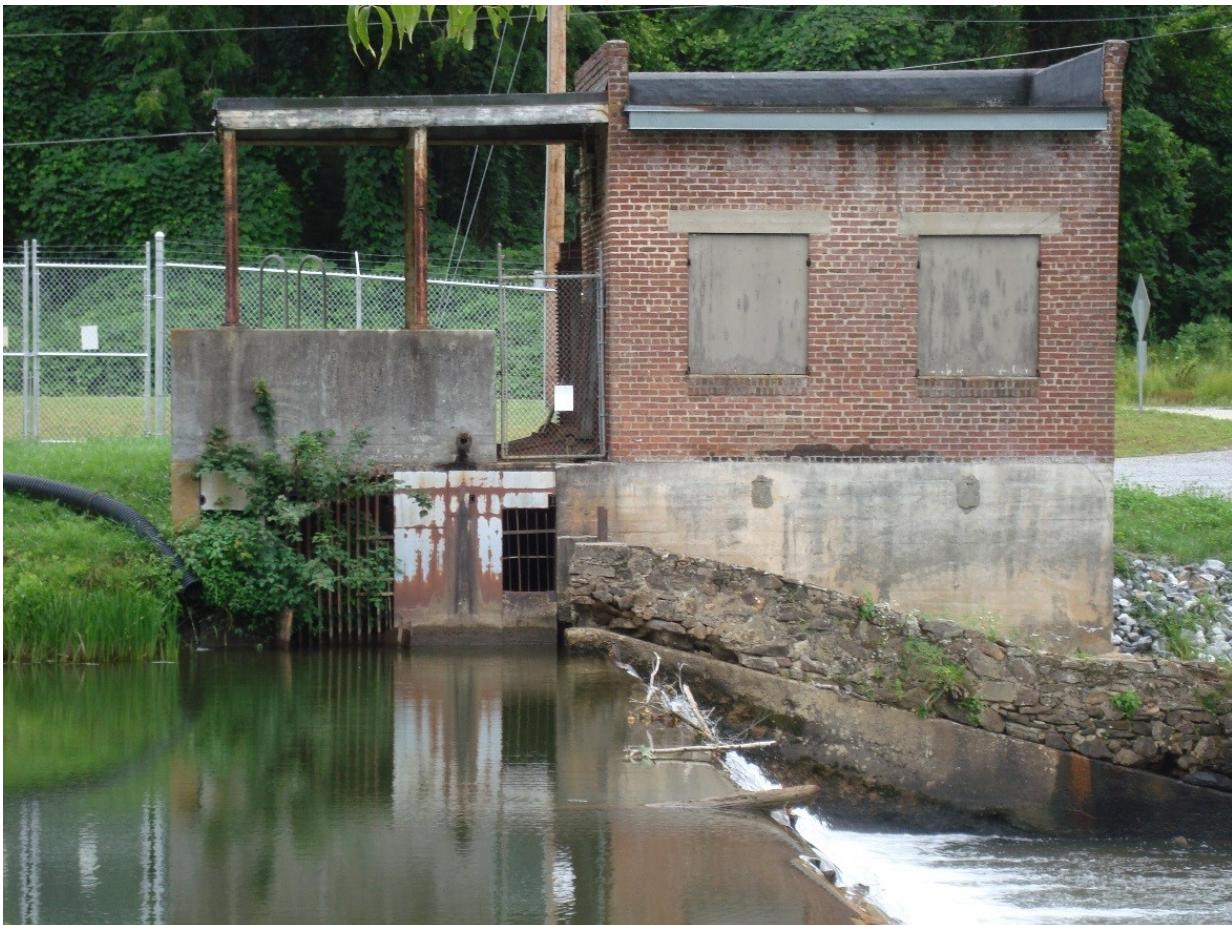
Figure 10. Powerhouse Intake and Left Abutment of Cullowhee Dam

According to the 1941 engineering report (Vanderhoof, 1941), the hydroelectric plant was rebuilt in 1934 and contained a Leffel turbine, A-C generator of 125 kVA capacity, exciter, speed changer, speed and lubricant controls, and associated switch board controls. Available drawings and field measurements indicate the powerhouse structure to be 18 feet 9 inches long (upstream to downstream) and nearly 16 feet wide, with a structural height of nearly 36 feet above its foundation (approximately 6 feet below the dam foundation). The powerhouse superstructure consists of brick walls with a 4-foot wide entrance door on the south side, and two windows each on the north and west sides, with a concrete substructure. Flows would enter an upstream 12-foot wide trash raked intake structure parallel to the river (as shown on Figure 10), and pass through two 6-foot wide gated openings to the turbine. The intake and powerhouse substructure currently appear to be plugged with sediment, and there was no evidence of the draft tube outlet at the downstream face of the structure (likely due to its depth). This was confirmed by In-Water Services in April 2016 when they performed an underwater inspection of the site. The 2004 inspection report (Sutton-Kennerly & Associates, 2004) indicated that hydroelectric power generation continued until the late 1960s. Much of the original generating equipment appears to remain intact. Numerous sand

boils were observed at the downstream face of the powerhouse below about a foot of water depth (as shown on Figure 11), suggesting a hydraulic gradient between the inside and the outside of the structure with some interconnection. This is not of any concern, given the concrete structure is founded deep into bedrock and that some piping of sediment may be occurring from a buried structure opening under a few feet of head.

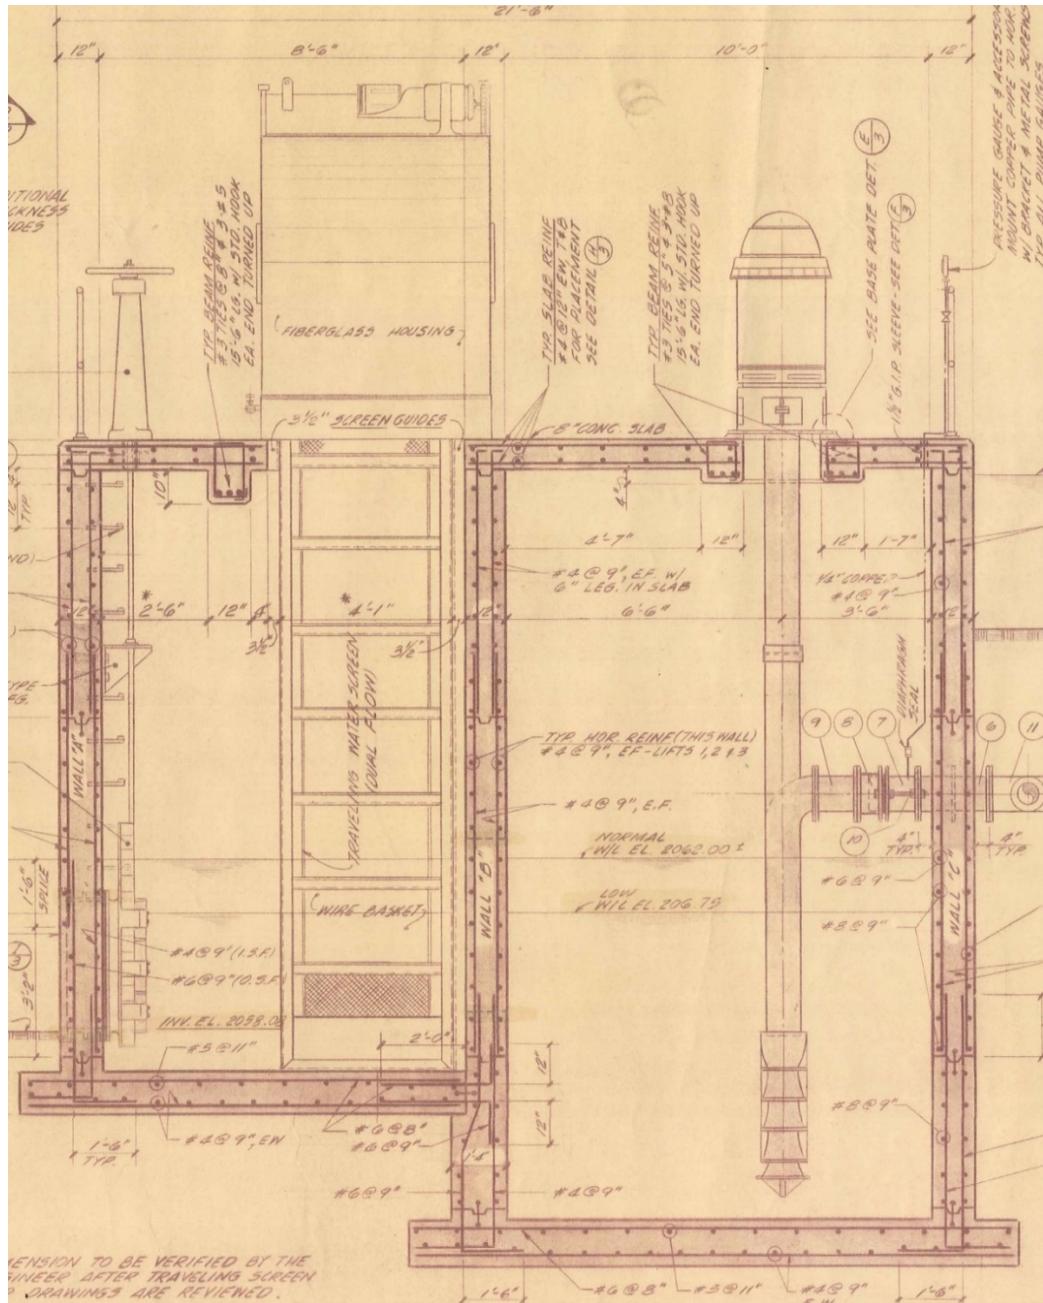
Figure 12. Section View of WCU Intake Structure

Constructed in 1977, the WCU intake structure consists of three chambers: an 18.5' x 14' screening chamber containing both a bar screen and a traveling screen, a 10' x 14" wet well, and a valve vault. (See Figure 12, valve vault not shown.) The wet well invert is 4'11" lower than the inlet, allowing the pumps to remain sufficiently submerged to operate at any water surface elevation that permits the screens to function.

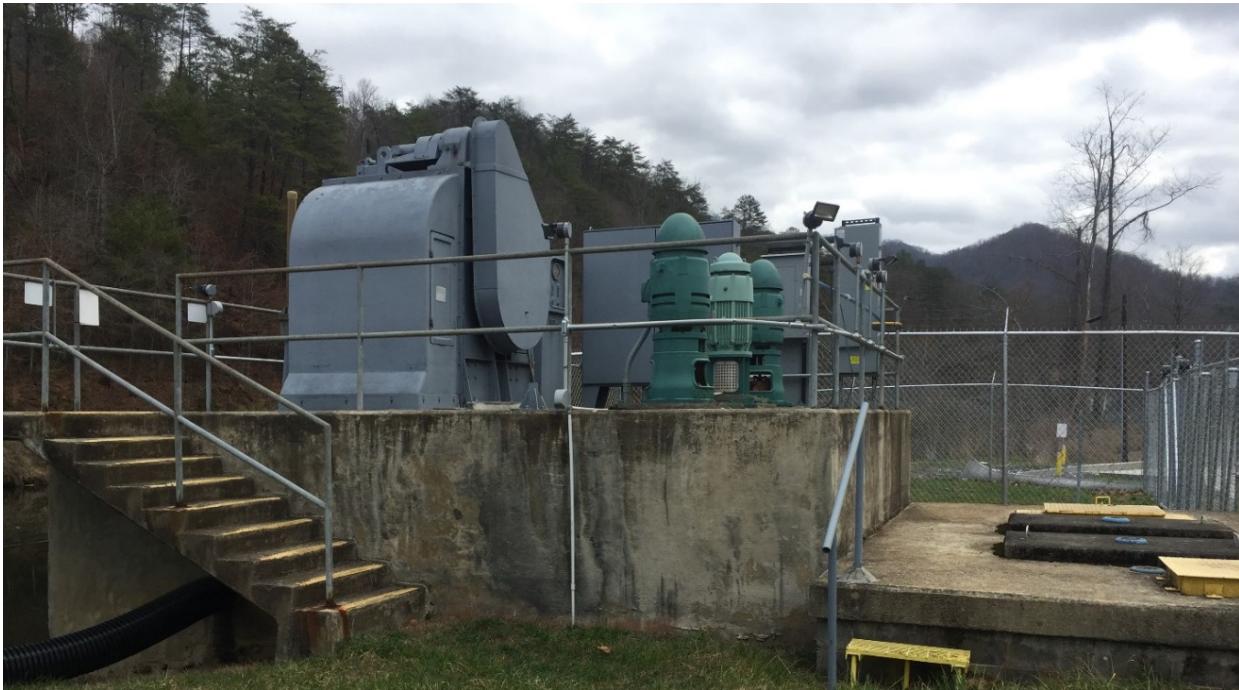
Figure 14. WCU Intake Traveling Screen and Pumps

The screening chamber contains a manually operated traveling screen oriented perpendicular to the bar screen that catches debris and discharges it back to the river. The traveling screen was apparently intended to operate automatically and be triggered by head loss, but is currently operated locally approximately once per week by WCU staff.

The WCU intake wet well has an invert elevation of 2054.06' and is drained by three pumps: two Worthington 30 hp 6-stage vertical turbine pumps that were relocated to the current WCU pump station in 1977 with a combined 1 MGD capacity (one pump is capable of pumping 550 gallons per minute (gpm) alone and the other is capable of pumping 500 gpm), and a newer and larger Ruhrpumpen 50 hp 6-stage vertical turbine pump installed in 2010 capable of pumping 690 gpm alone. The pumps, control panel, and traveling screen, (shown in Figure 14), are located outside but are protected from tampering by a chain link fence around the intake building. There is no backup generator for this pump station, however WCU does have the ability to connect a portable generator available on campus.

The intake is functioning adequately at present despite the age of two of its pumps. If conditions do not change it is likely to continue functioning until an expansion is needed. At that time, the wet well and screens are likely to continue to be adequate to permit inflow of raw water so that only pump replacement and piping modifications would be necessary. A more detailed instream study should be performed before any capacity increase is designed.

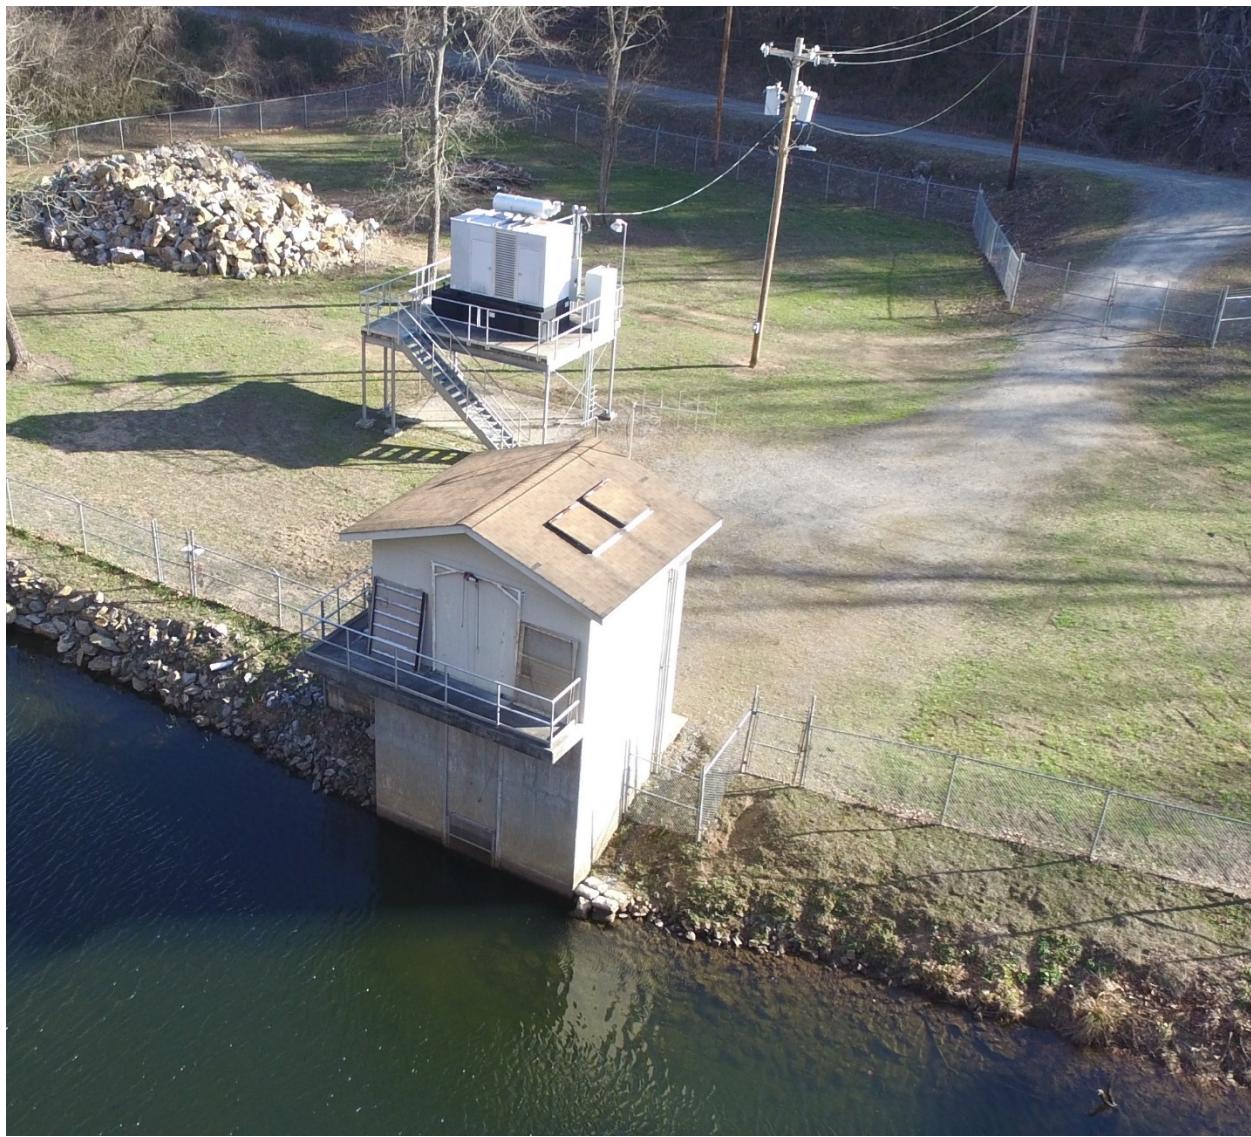
Figure 15. TWSA Intake Structure and Generator

The TWSA intake structure was constructed in 1994 with a single chamber design consisting of a 12'8" x 16' concrete wet well whose screen takes in flow directly from the Tuckaseigee River. Its controls and mechanical equipment are housed in an enclosed room directly above the wet well.

The wet well is drained by two 100 hp vertical turbine pumps, each capable of pumping 1,050 gallons per minute. The pumps and controls can be powered by a backup generator located on an elevated platform behind the intake building (visible in Figure 15).

This intake structure is also functioning adequately. With proper maintenance it is likely to continue to perform acceptably until increased demand necessitates expansion. At that time, the existing screen should be capable of permitting sufficient raw water inflow so that pump replacement will be the only necessary modification. As with the WCU intake, an in-stream flow study should be performed prior to any capacity increase.

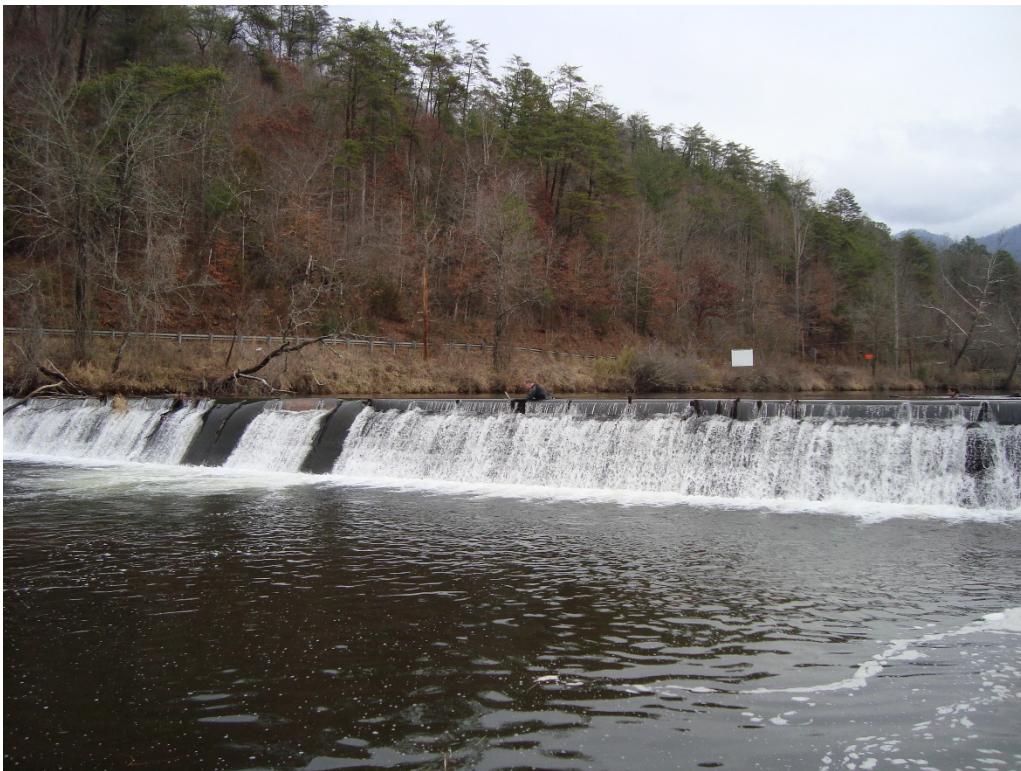
Figure A- 13 – Close-up View of Unwatered Downstream Face of Dam (January 2, 2017)

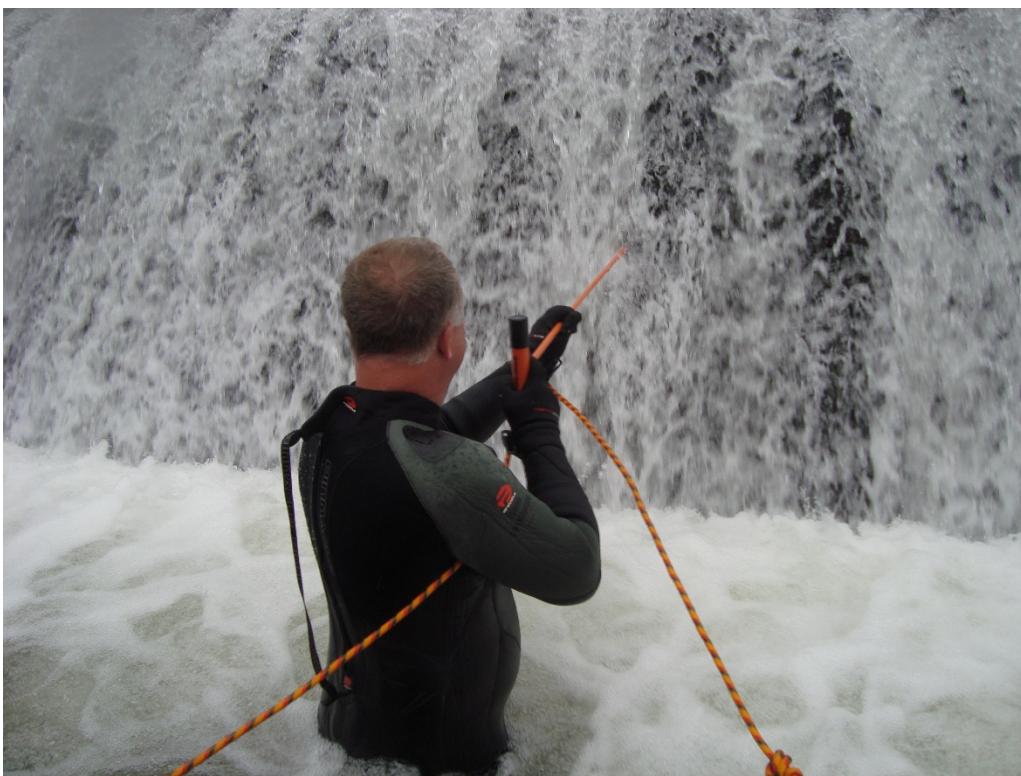
Figure A- 14 - Overall View of Downstream Face during Drawdown (January 2, 2017)

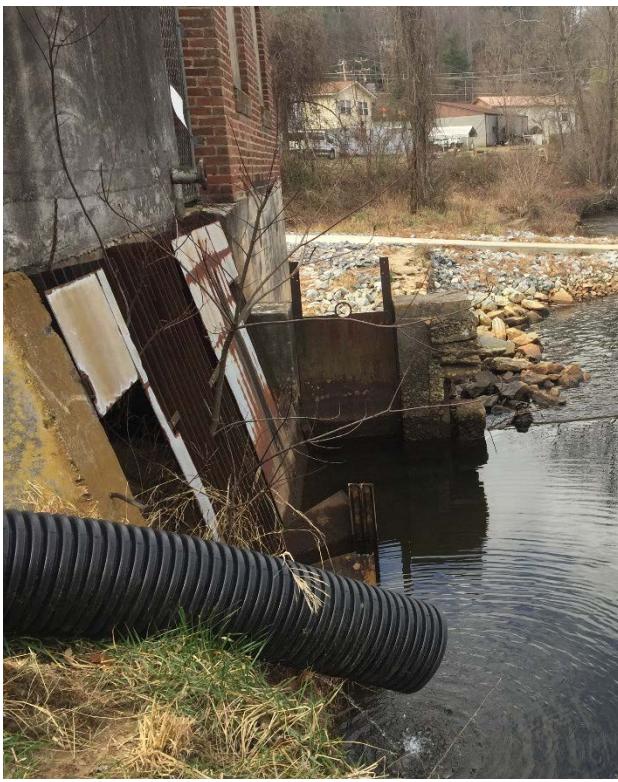
In-Water Services (Mike Brian) reported a large undercut area at the downstream toe of the overflow section approximately 60 feet from the right abutment (station 0+65, as shown on Figure 6), which extended at least 3.5 feet upstream beneath the downstream toe of the concrete structure. This area also generally coincided with an area of little or no sediment upstream, and may have originally represented the thalweg (line of lowest elevation within a watercourse) of the river. The undercut was estimated to be approximately 3-feet wide and 1.5-feet high at the toe, and appeared to be within the structure foundation. No other evidence of structure undercutting was observed, other than a reported 3 to 4 inches near the left abutment (station 1+50), which would be considered minor. Tailwater was generally waist-deep for the majority of the overflow section, with somewhat shallower depths closer to the abutments. In-Water Services also measured the depths below the reservoir water surface to the top of the impounded sediment at 5-foot intervals along the upstream face of the overflow section, which were recorded and are shown on Figure 1. Again, shallower water depths were reported closer to the abutments. Two samples collected of the reservoir sediment were visually classified as silty fine sand near the powerhouse intake and fine to medium sand closer to the overflow section.

Figure A- 16 - In-Water Services Personnel at Location of 3.5-Foot Deep Undercut Area (January 2, 2017)

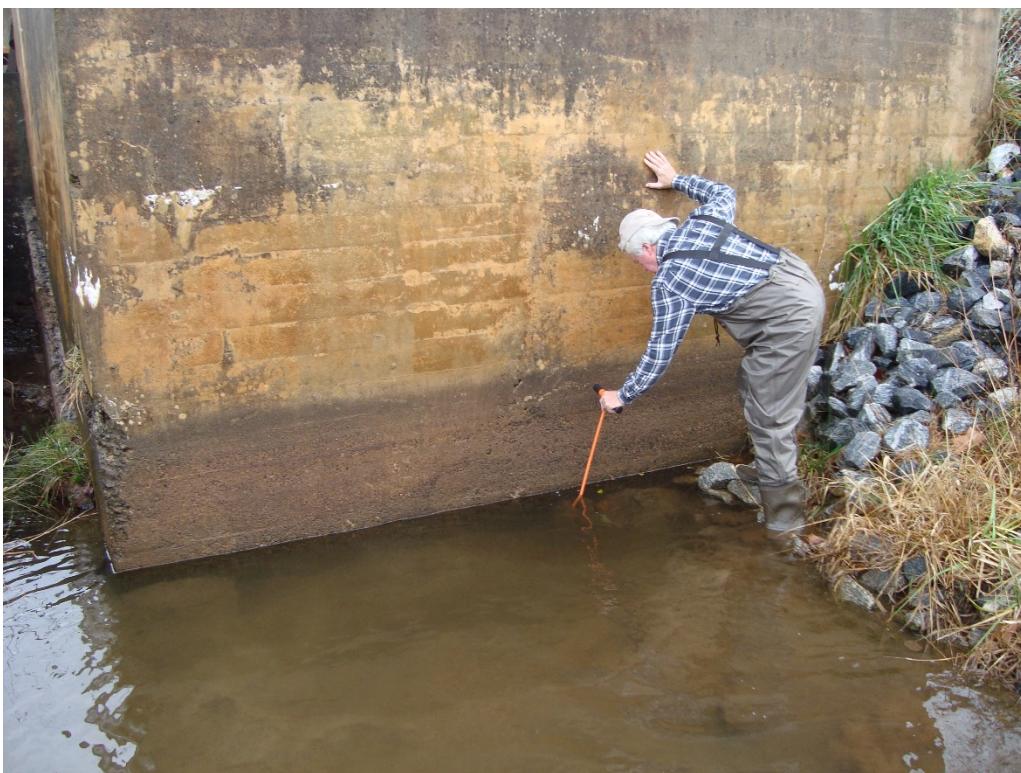
Figure A- 20 - Sand Boils at Downstream End of Powerhouse (January 2, 2017)
